Technicians Annual Service Guide.

Introduction: Annual service of Hallett UV

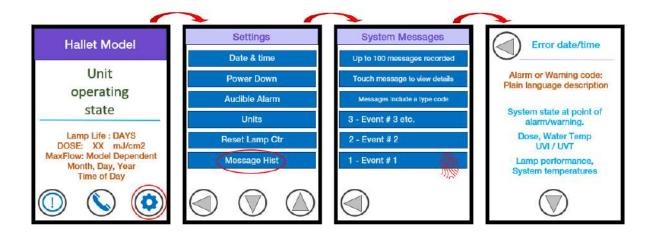
Press the information button. Use the DOWN button

Record the values on your annual service sheet (example supplied Appendix 2, Page XX)

- Record the total lamp starts.
- 2. Total Starts
- 3. Power Ups
- 4. Lifetime counter
- 5. Check the unit message history.

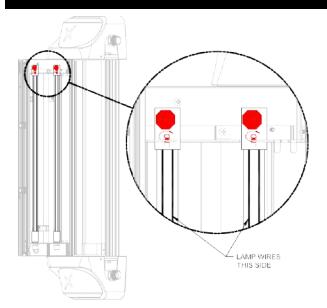
8. Replace both lamps

Install the lamps with the vertical wires facing toward you (away from the reflector)

When handling the lamps to avoid touching the glass with bare skin

LPHO lamps (Hallett 500 and 750 models) require an initial 3 – 4 hr 'burn-in' period and may not achieve their full output for 24hrs. After 15 minutes operation, the UVI value for the new lamps should be equal to or greater than the aged lamps.

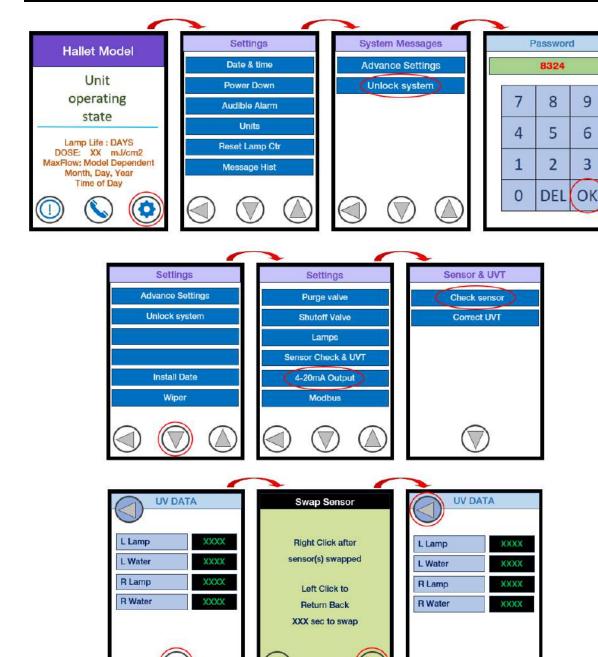
13. UV sensor reference check

With the sensor removed, UV light from the lamps is visible. Exercise caution. Do not look inside the chamber
